The Characterization and Analysis of Ornamental Cast Stone and Stucco from the Palacio Errazuriz, Buenos Aires, Argentina

James Valente Banta
University of Pennsylvania

THE CHARACTERIZATION AND ANALYSIS OF ORNAMENTAL
CAST STONE AND STUCCO FROM THE PALACIO ERRÁZURIZ,
BUENOS AIRES, ARGENTINA

Historic Preservation

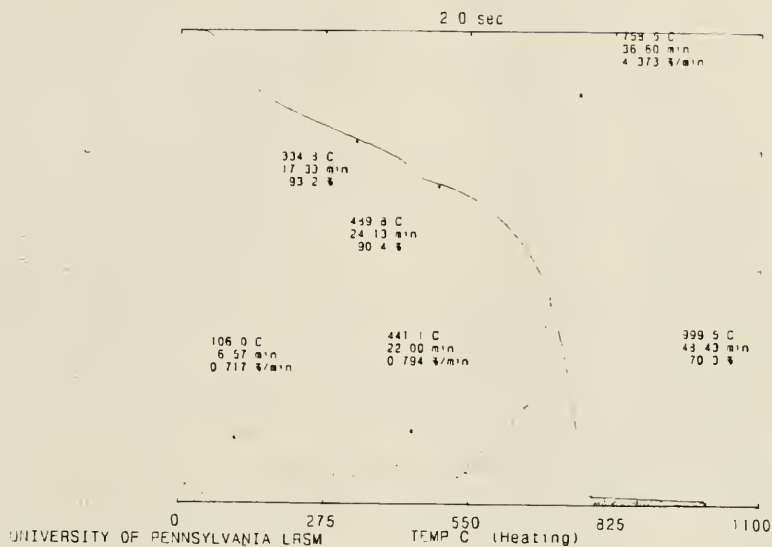
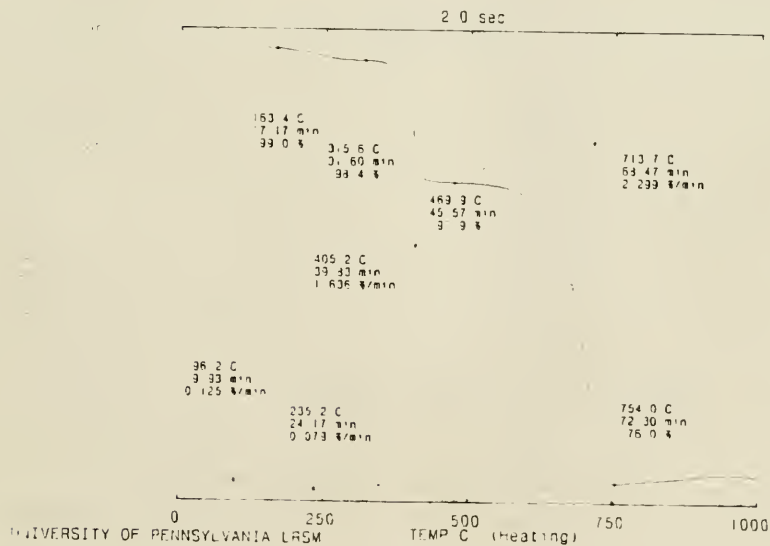
13.4.2. Sample ER 2 (top) compared with Standard for Hydraulic Lime (bottom)

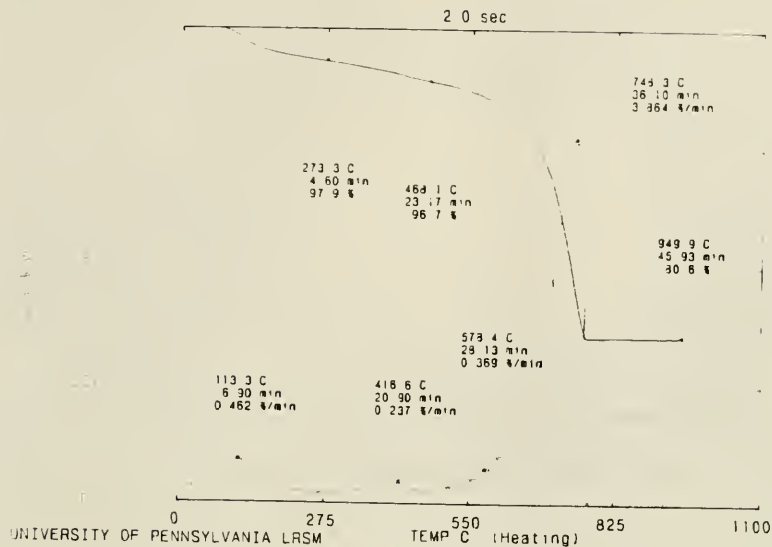
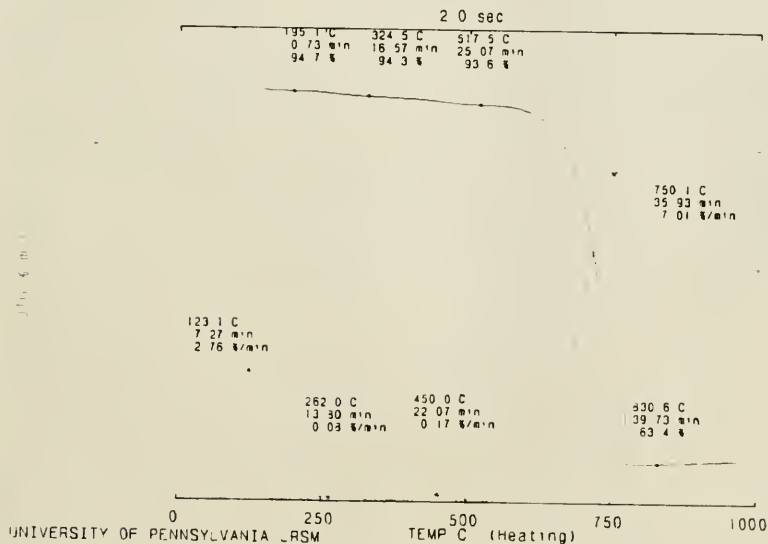
13.4.3. Sample ER 28 (top) compared with
Standard for Lime and Gypsum (bottom)
